# **U.S. Navy Salvage Report TWA Flight 800**

# U.S. NAVY SALVAGE REPORT TWA FLIGHT 800

This report on the salvage of the victims and wreckage of TWA Flight 800 documents the techniques and procedures that were used in this difficult operation. The report is intended to serve two purposes. First, it documents the actual conduct of the operation. Secondly, and more importantly, the report provides lessons learned so that if confronted with an event of this nature in the future, the salvage team will have a ready reference to draw upon.

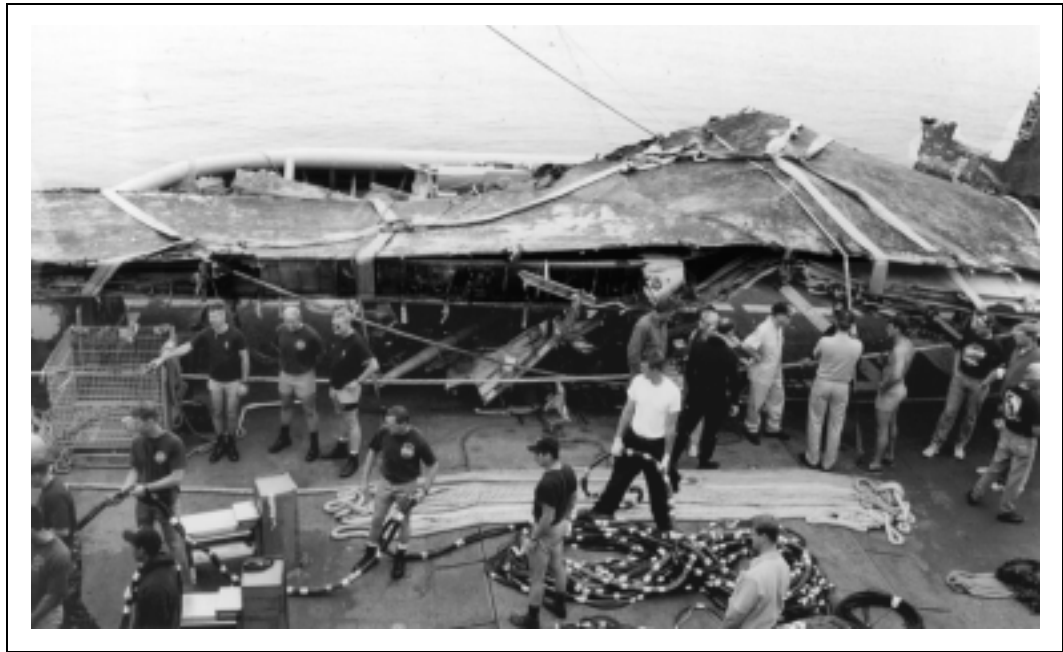
**Figure 5-1. Starboard Wing Section.** Large, jagged pieces of wreckage were difficult to rig, lift, and transport. Pictured above is an 80-foot section of the starboard wing aboard the USS GRASP.

Larger items, which were lifted directly by GRASP, GRAPPLE, and the SLWT, presented their own particular set of problems (see Figure 5-1 and Figure 5-2). The limited visibility coupled with the catastrophic damage to the airframe made it difficult to judge the center of gravity for a balanced lift. The jagged edges were a hazard to the divers and quickly abraded lifting straps. Because of the quantity and size of the debris, the ships' decks quickly fouled, in some cases forcing diving operations to be suspended until debris could be taken ashore by LCM-8.

A few very large pieces, including the 80-foot long starboard wing section, had to be cut because they would not fit in the LCM-8s for the move ashore nor in the trucks to move to the hangar. This required both approval from the FBI and the NTSB and some innovation by the salvors. Conventional saws proved inadequate. After allaying concerns about the neatness of the cut, the salvors used Kerrie Cable, a pyrotechnic material normally used for underwater cutting, to cut these pieces to fit the available transport craft.

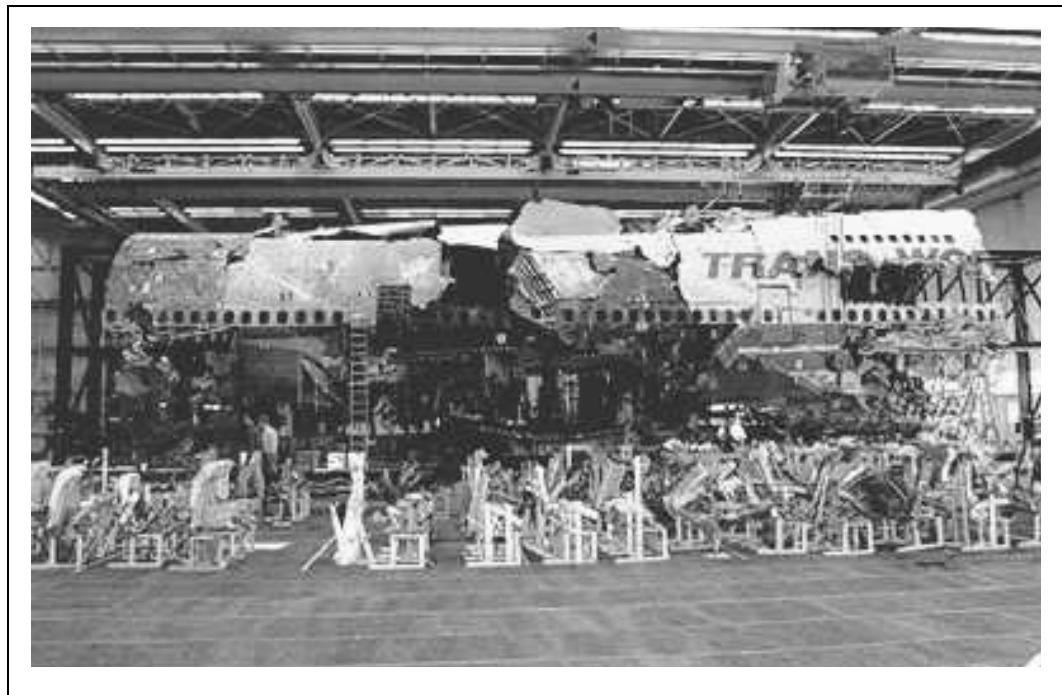
**Figure 5-4. Reconstruction of Wreckage at Calverton Hangar.** As part of its investigation, the NTSB used recovered wreckage to reconstruct portions of the aircraft. This photo shows a section of the fuselage, with passenger seats in the foreground.

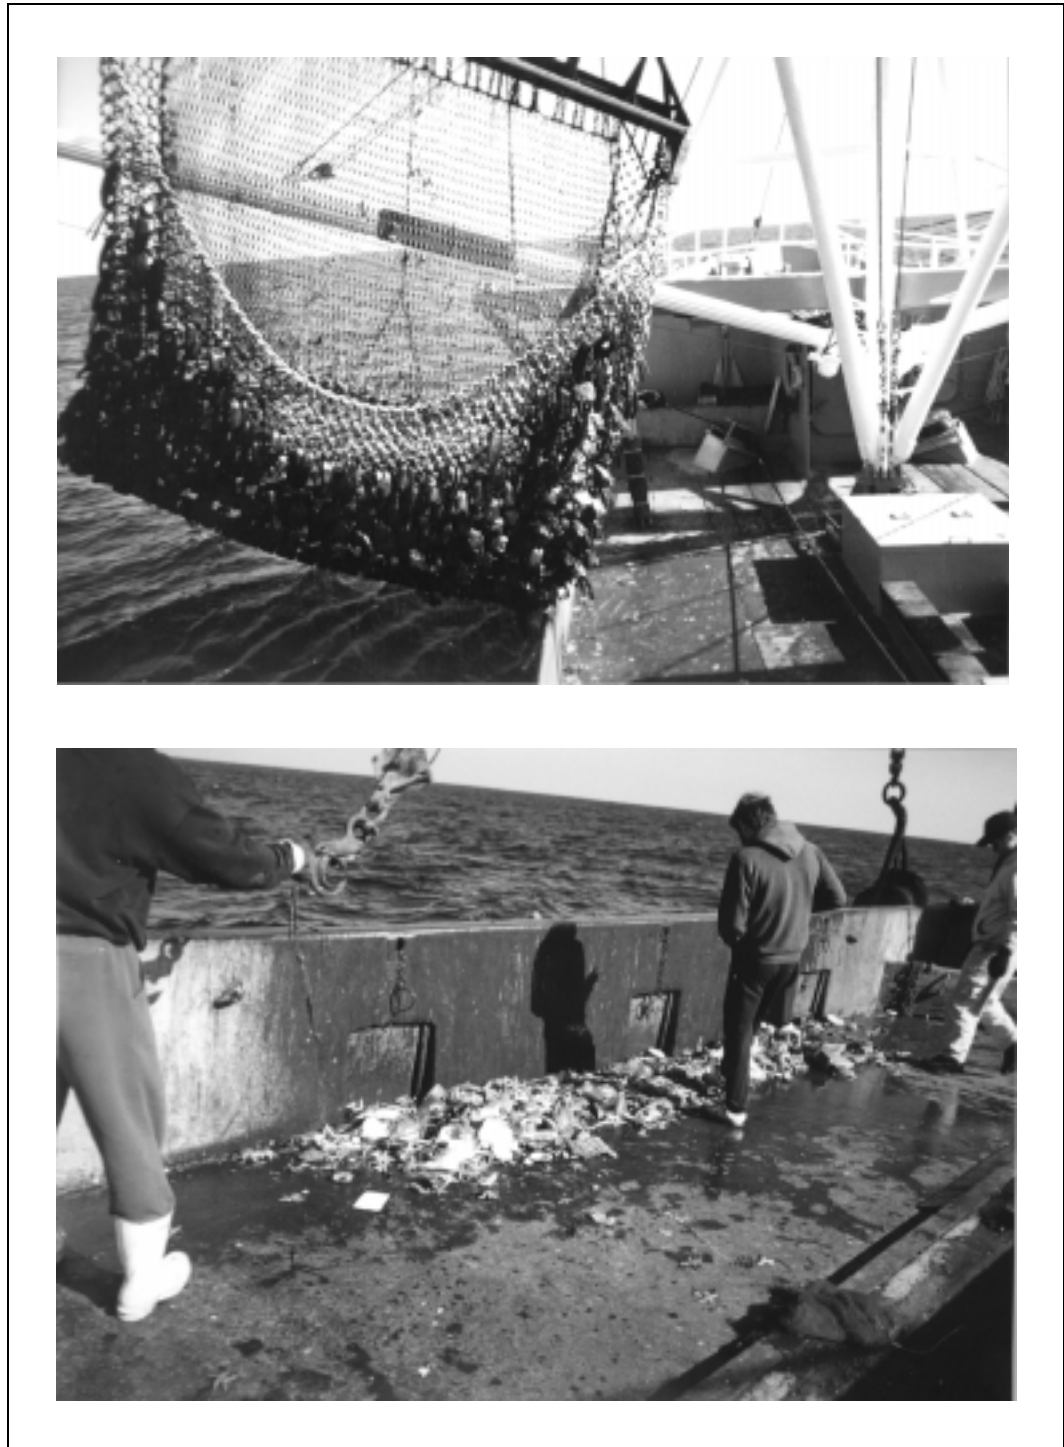
**Figure 5-6. Trawling Operations.** Top photo shows one of the 15-foot nets used for trawling. Bottom photo shows some of the small pieces of debris recovered from the ocean floor.

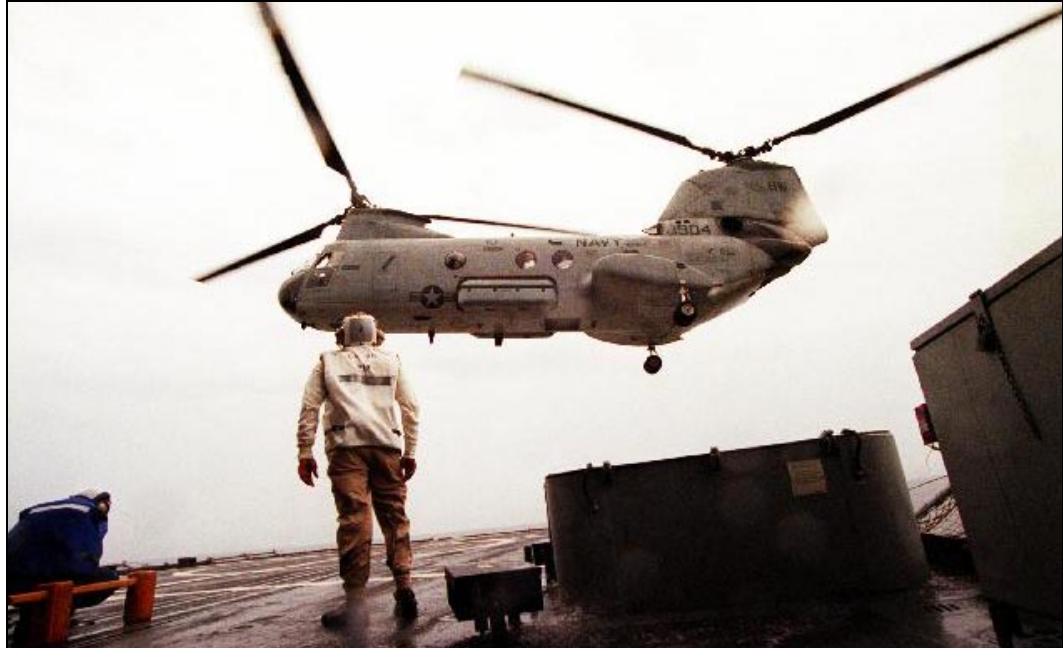
<i>Description:</i>	Cargo Helicopter
<i>Owner:</i>	U.S. Navy
<i>Primary assignment:</i>	Transportation of debris, personnel, and stores
<i>Period on site:</i>	23 July to 2 November 1996
<i>Fuselage Length:</i>	46 feet, 8 inches
<i>Height:</i>	16 feet, 8 inches
<i>Weight:</i>	15,198 pounds empty, 24,300 pounds maximum takeoff
<i>Crew:</i>	3 (1 pilot, 1 copilot, 1 crewman)
