U.S. Navy Salvage Report TWA Flight 800

U.S. NAVY SALVAGE REPORT TWA FLIGHT 800

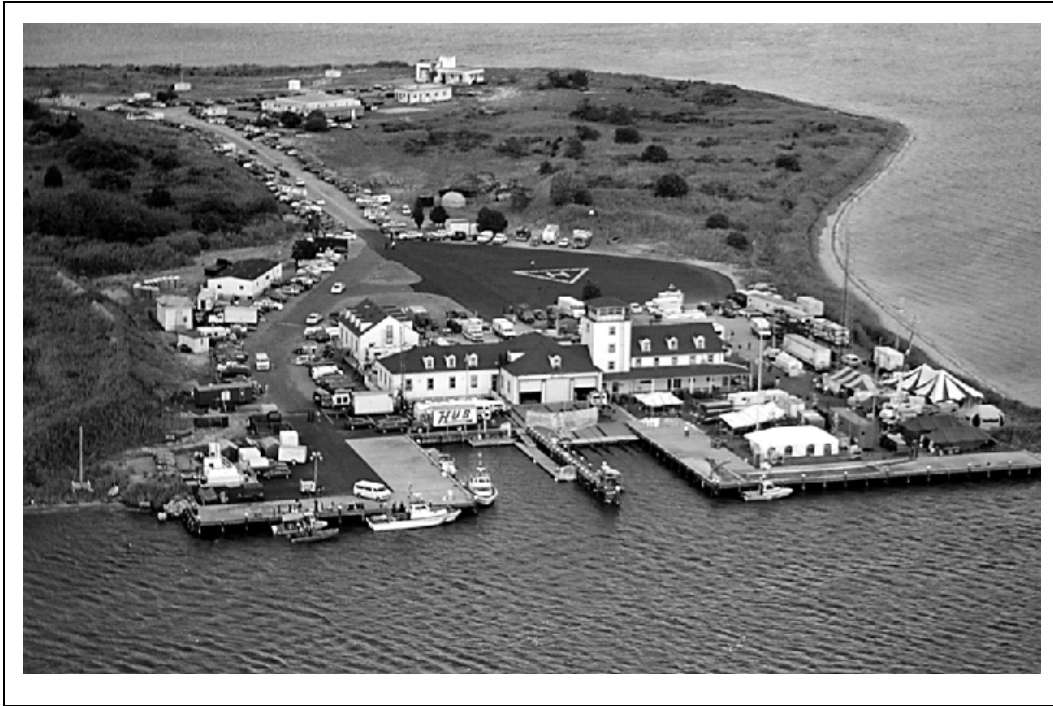
Figure 1-2. U.S. Coast Guard Station Moriches. Due to its proximity to the crash, the Coast Guard Station at East Moriches, NY, became the hub of the search and recovery operation. Here the Navy established its command and control center and facilities for data analysis, public affairs, and communications. Wreckage was transferred to shore at the Shinnecock Coast Guard Station.

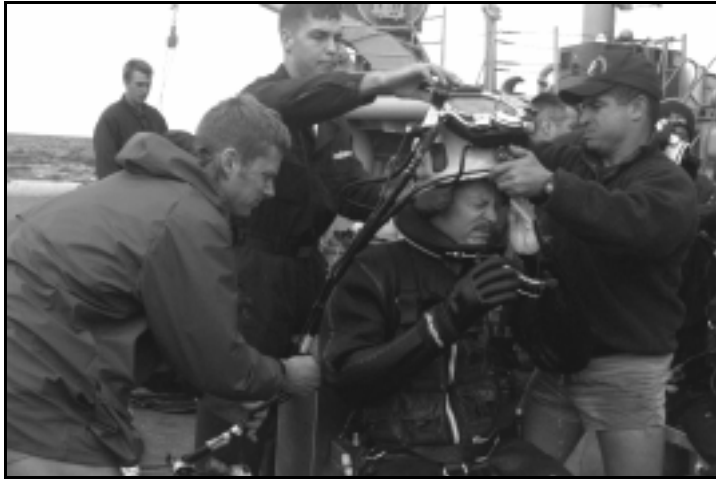
Surface-supplied dives:	677	ROVs used:	4
Surface supplied hours:	856	ROV dives:	376
		ROV hours:	2,679
Scuba dives:	3,667	Vessels	
Scuba hours:	917	Navy:	4
Total dives:	4,344	NOAA:	1
Total diving hours:	1,773	Contract:	9
Navy divers:	225 +		
Civilian divers:	150 +

Figure 1-4. Summary of Statistics. The Flight 800 operation was one of the largest diver-assisted salvage operations ever conducted.

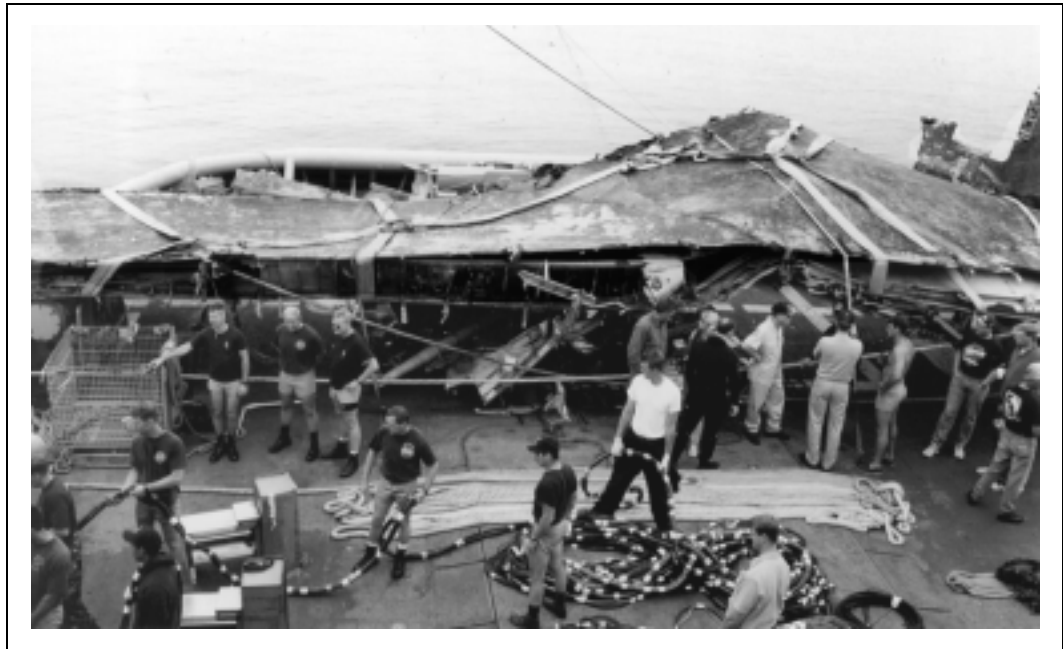
Figure 5-1. Starboard Wing Section. Large, jagged pieces of wreckage were difficult to rig, lift, and transport. Pictured above is an 80-foot section of the starboard wing aboard the USS GRASP.

Larger items, which were lifted directly by GRASP, GRAPPLE, and the SLWT, presented their own particular set of problems (see Figure 5-1 and Figure 5-2). The limited visibility coupled with the catastrophic damage to the airframe made it difficult to judge the center of gravity for a balanced lift. The jagged edges were a hazard to the divers and quickly abraded lifting straps. Because of the quantity and size of the debris, the ships' decks quickly fouled, in some cases forcing diving operations to be suspended until debris could be taken ashore by LCM-8.

A few very large pieces, including the 80-foot long starboard wing section, had to be cut because they would not fit in the LCM-8s for the move ashore nor in the trucks to move to the hangar. This required both approval from the FBI and the NTSB and some innovation by the salvors. Conventional saws proved inadequate. After allaying concerns about the neatness of the cut, the salvors used Kerrie Cable, a pyrotechnic material normally used for underwater cutting, to cut these pieces to fit the available transport craft.

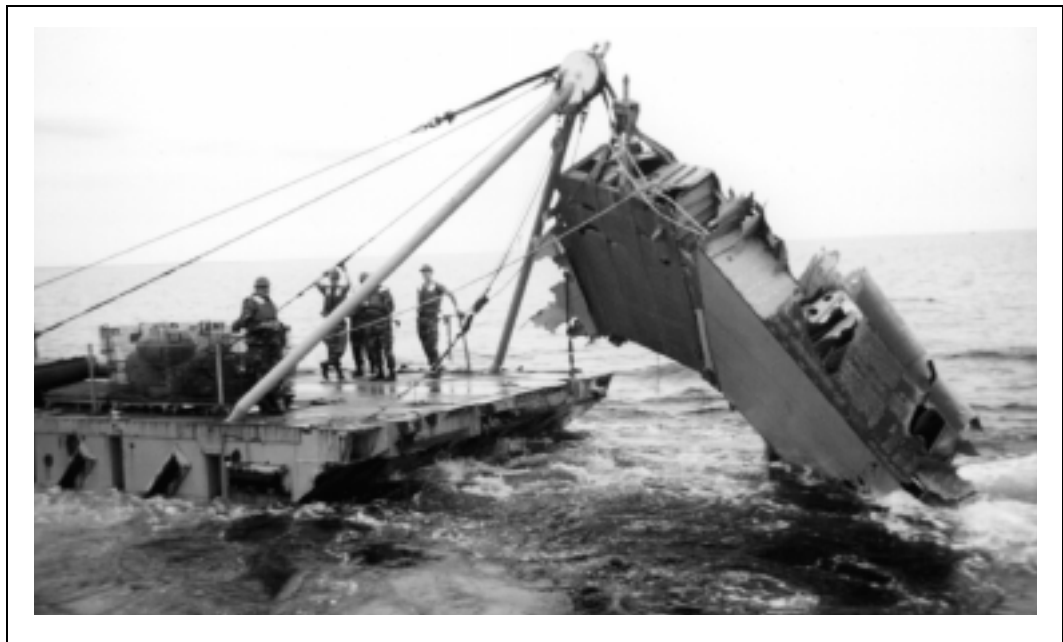
Figure 5-2. Tail Section. The Side Loading Warping Tug worked with the Mobile Dive Teams to recover large pieces of wreckage, such as this tail section.

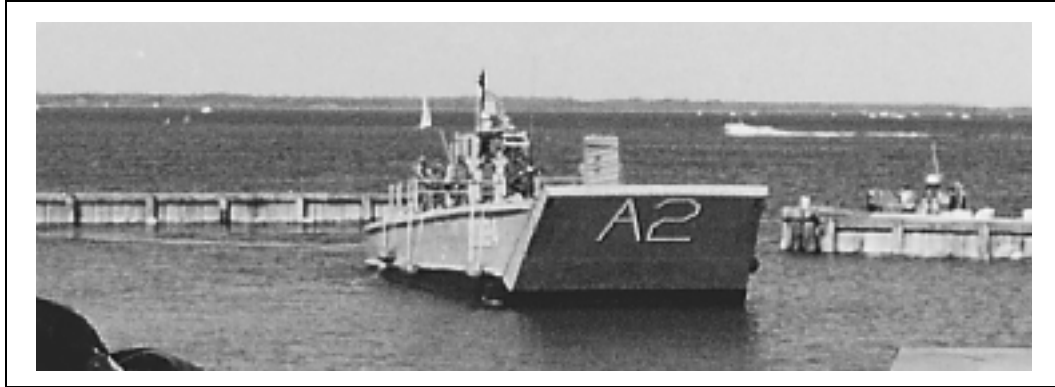
Figure 5-3. LCM-8 Support Craft. LCM-8s, also known as “Mike boats,” proved invaluable for shuttling debris and trash to shore and stores to ships.

The ship-to-shore transfer of debris was more problematic. Some items, particularly small or important pieces, were carried by CH-46 Sea Knight helicopters operating from the OAK HILL or TRENTON. Most material, however, went ashore on the two LCM-8s (see Figure 5-3).

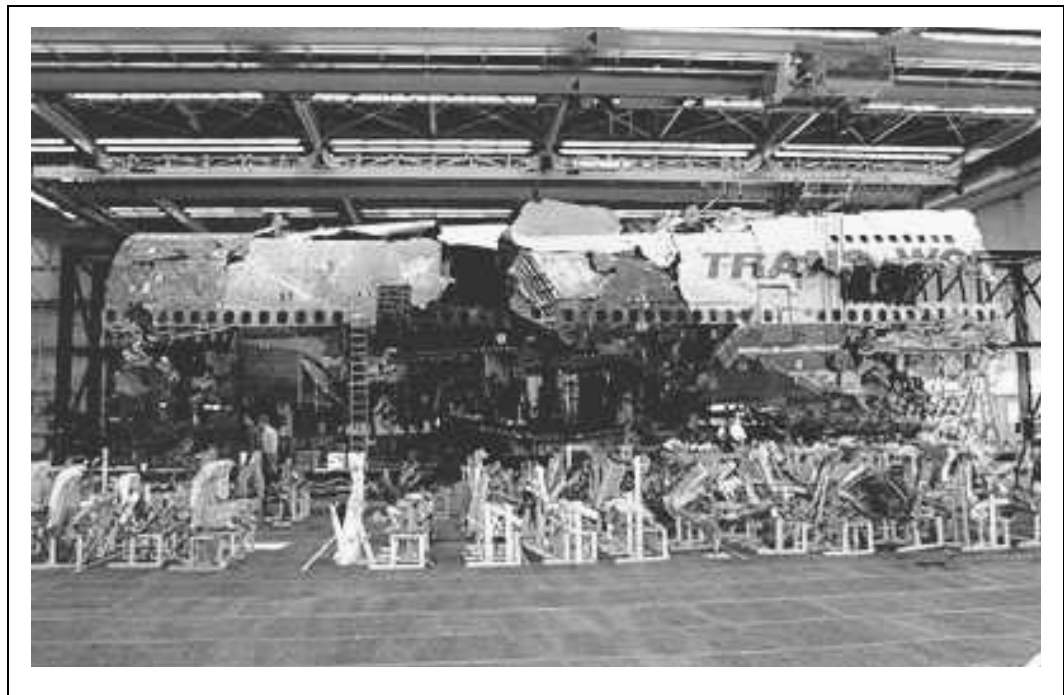
Figure 5-4. Reconstruction of Wreckage at Calverton Hangar. As part of its investigation, the NTSB used recovered wreckage to reconstruct portions of the aircraft. This photo shows a section of the fuselage, with passengers seats in the foreground.

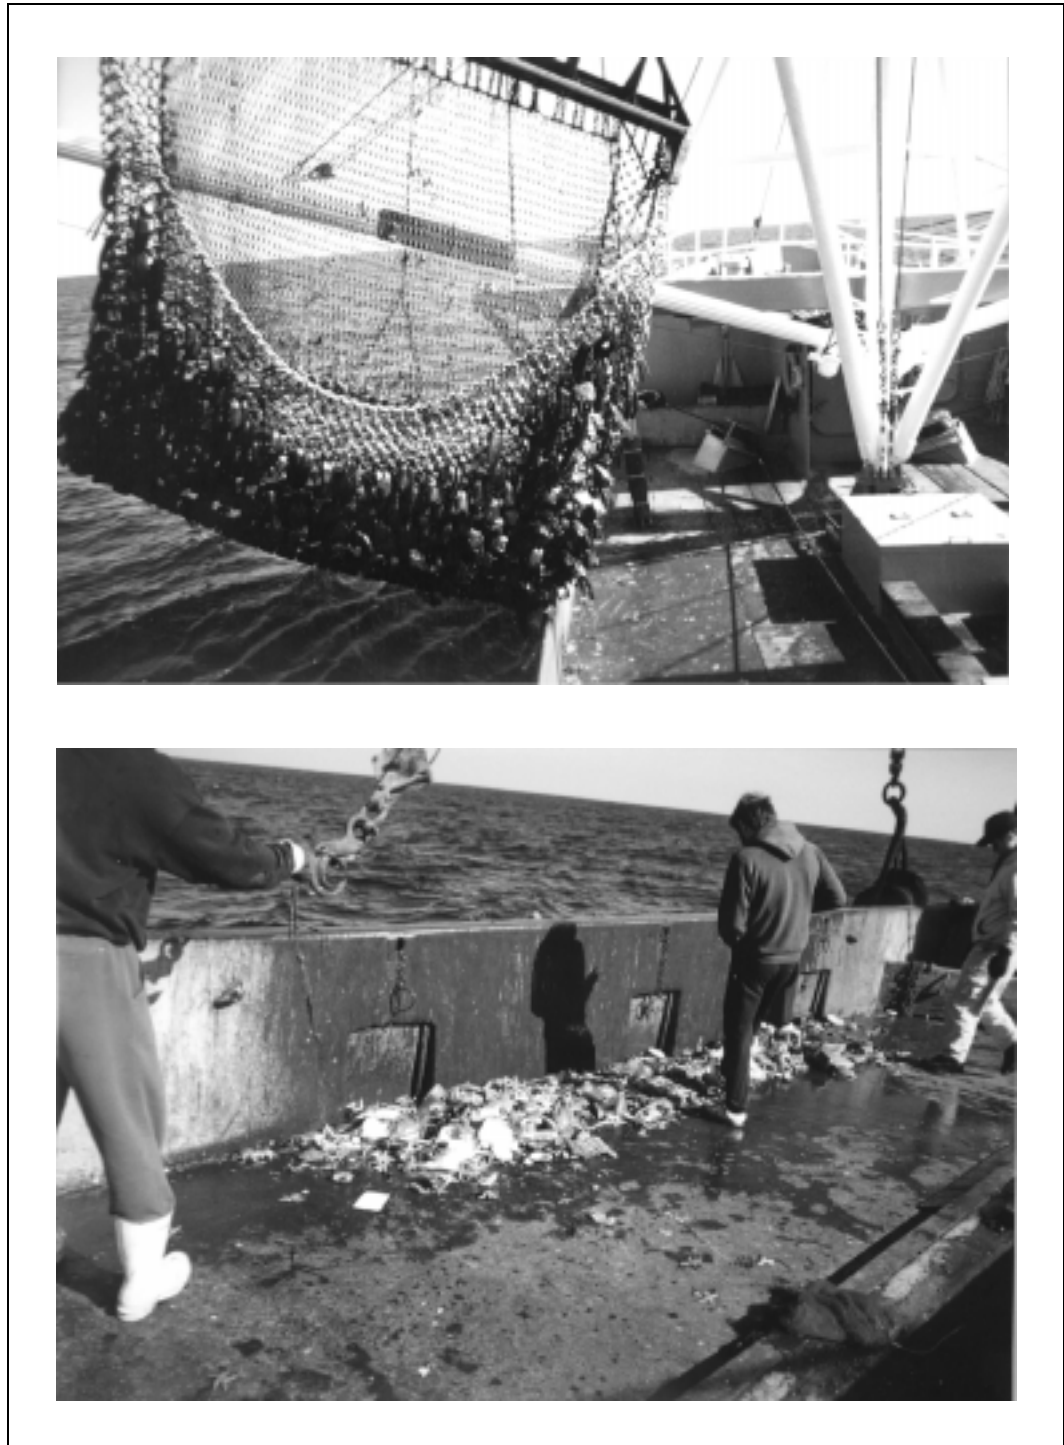
Figure 5-6. Trawling Operations. Top photo shows one of the 15-foot nets used for trawling. Bottom photo shows some of the small pieces of debris recovered from the ocean floor.

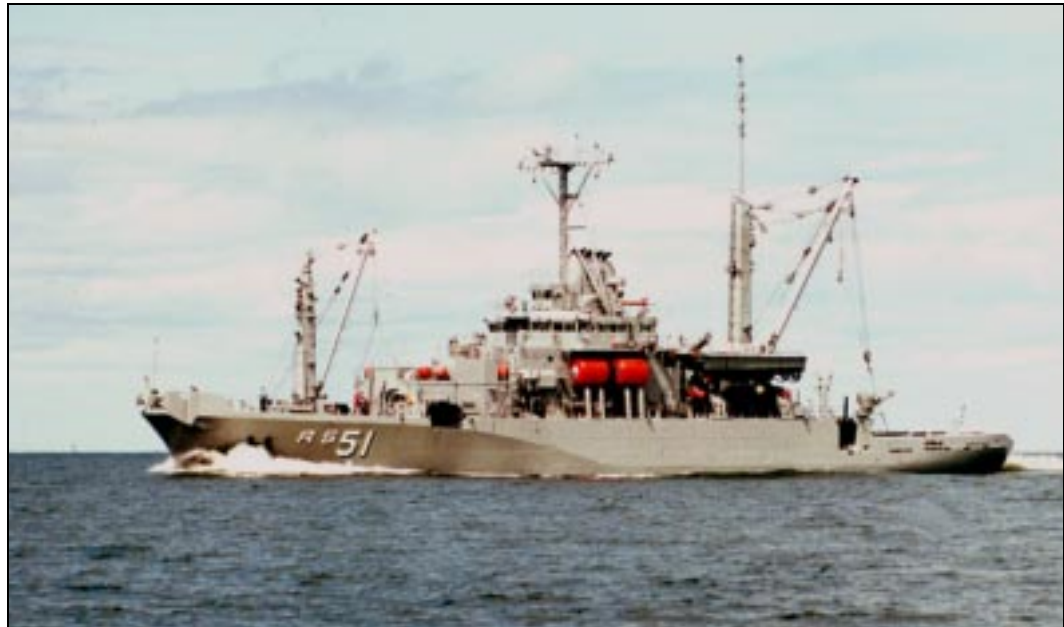
USS GRASP (ARS 51)

<i>Description:</i>	Rescue and Salvage Ship
<i>Owner:</i>	U.S. Navy
<i>Features:</i>	Heavy lift capabilities Ample deck area Diver life support system, including recompression chamber
<i>SUPSALV systems:</i>	Mini-ROV 1 (see page B-18)
<i>Primary assignment:</i>	Recovery of victims and heavy debris from bulk of aircraft (Debris Field 1)
<i>Period on site:</i>	22 July to 27 August 1996
<i>Length:</i>	255 feet
<i>Beam:</i>	51 feet
<i>Displacement:</i>	2880 tons fully loaded
<i>Complement:</i>	101 (6 officers, 95 enlisted)
<i>Diving Systems:</i>	MK 21 Deep Sea Air, Air SCUBA
<i>Cargo Handling Capacity:</i>	Aft boom 80,000 lbs. Forward boom 15,000 lbs.

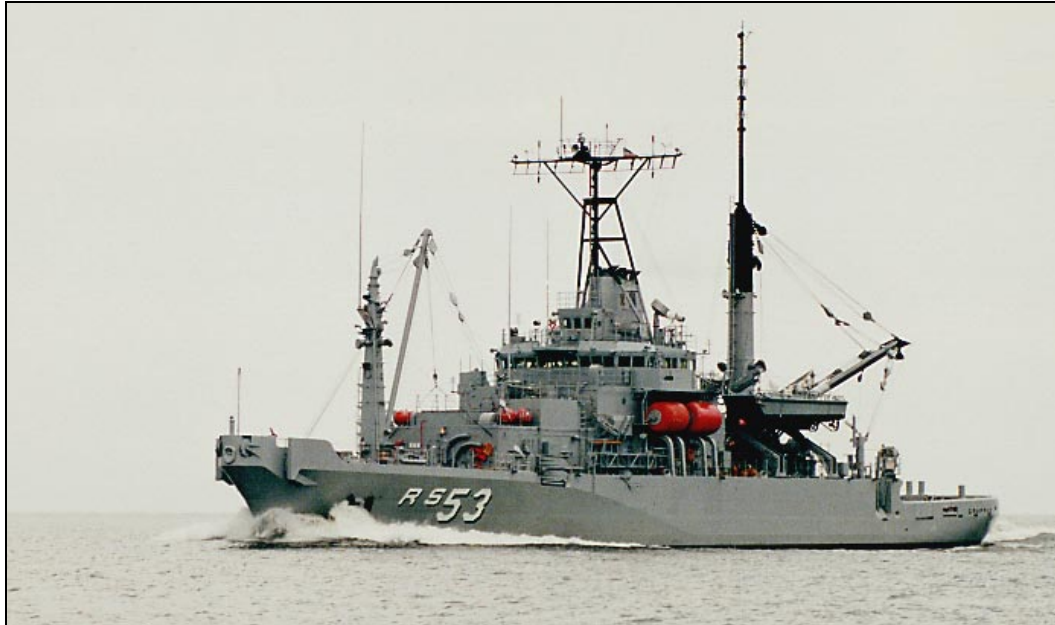
USS GRAPPLE (ARS 53)

<i>Description:</i>	Rescue and Salvage Ship
<i>Owner:</i>	U.S. Navy
<i>Features:</i>	Heavy lift capabilities Ample deck area Diver life support system, including recompression chamber
<i>SUPSALV systems:</i>	Deep Drone 7200 (see page B-20)
<i>Primary assignment:</i>	Recovery of victims and heavy debris from the first class section and cockpit of the aircraft (Debris Field 2)
<i>Period on site:</i>	29 July to 1 November 1996
<i>Length:</i>	255 feet
<i>Beam:</i>	51 feet
<i>Displacement:</i>	2880 tons fully loaded
<i>Complement:</i>	101 (6 officers, 95 enlisted)
<i>Diving Systems:</i>	MK 21 Deep Sea Air, Air SCUBA
<i>Cargo Handling Capacity:</i>	Aft boom 80,000 lbs. Forward boom 15,000 lbs.

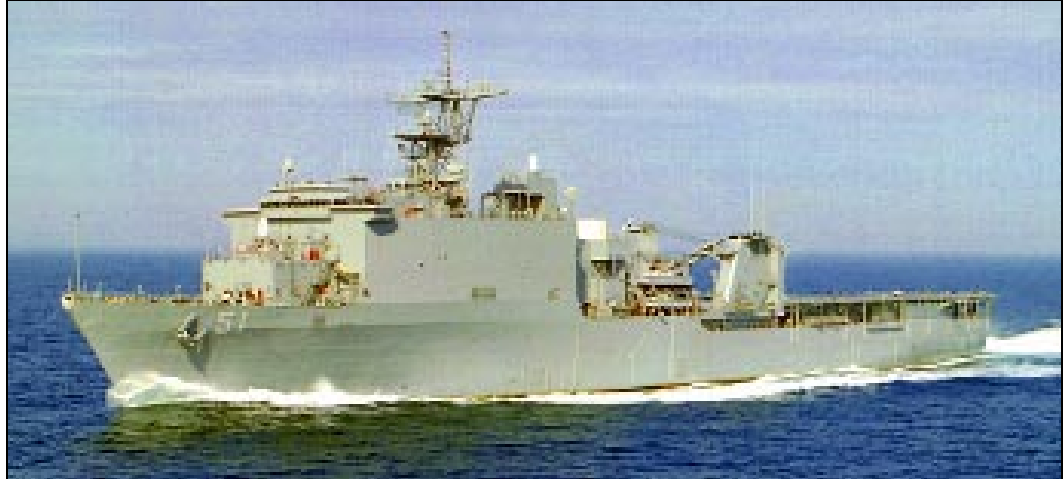
USS OAK HILL (LSD 51)

<i>Description:</i>	Dock Landing Ship
<i>Owner:</i>	U.S. Navy
<i>Features:</i>	Docking well for LCM-8 landing craft (see page B-14) and Side Loading Warming Tug (see page B-13) Landing area for CH-46 Helicopter (see page B-15) Berthing for divers
<i>Primary assignment:</i>	Afloat Command Post
<i>Period on site:</i>	23 July to 10 September 1996
<i>Length:</i>	609 feet
<i>Beam:</i>	84 feet
<i>Displacement:</i>	16,708 tons fully loaded
<i>Complement:</i>	419 (22 officers, 397 enlisted)

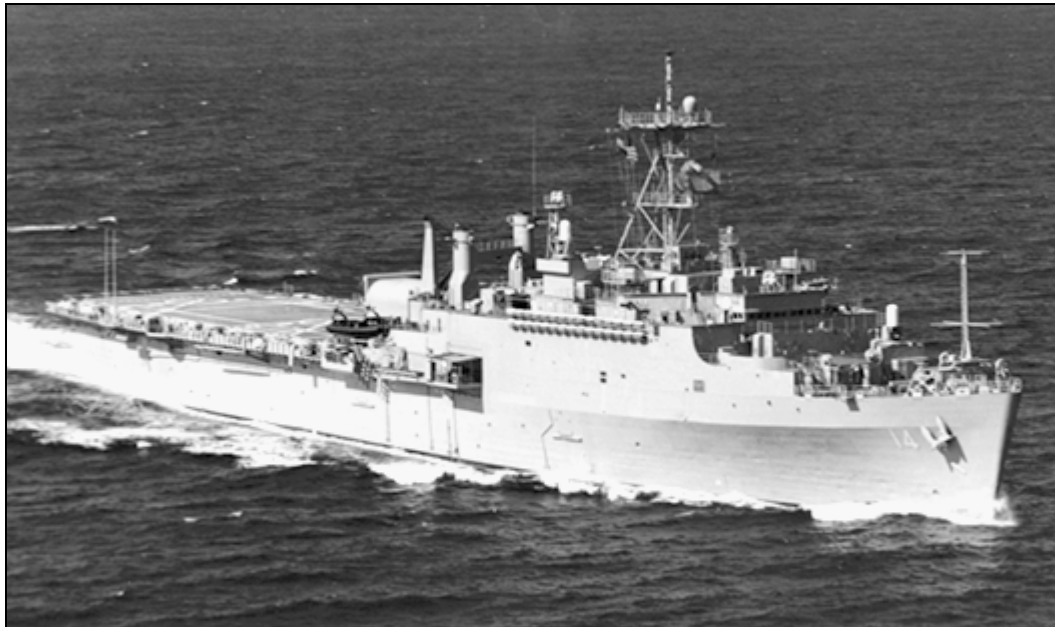
USS TRENTON (LPD 14)

<i>Description:</i>	Amphibious Transport Dock
<i>Owner:</i>	U.S. Navy
<i>Features:</i>	Docking well for LCM-8 landing craft (see page B-14) and Side Loading Warming Tug (see page B-13) Hangar and landing area for CH-46 Helicopter (see page B-15) Berthing for divers
<i>Primary assignment:</i>	Afloat Command Post (relieved USS OAK HILL)
<i>Period on site:</i>	10 September to 18 October 1996
<i>Length:</i>	570 feet
<i>Beam:</i>	84 feet
<i>Displacement:</i>	Approximately 17,000 tons fully loaded
<i>Complement:</i>	420 (24 officers, 396 enlisted)

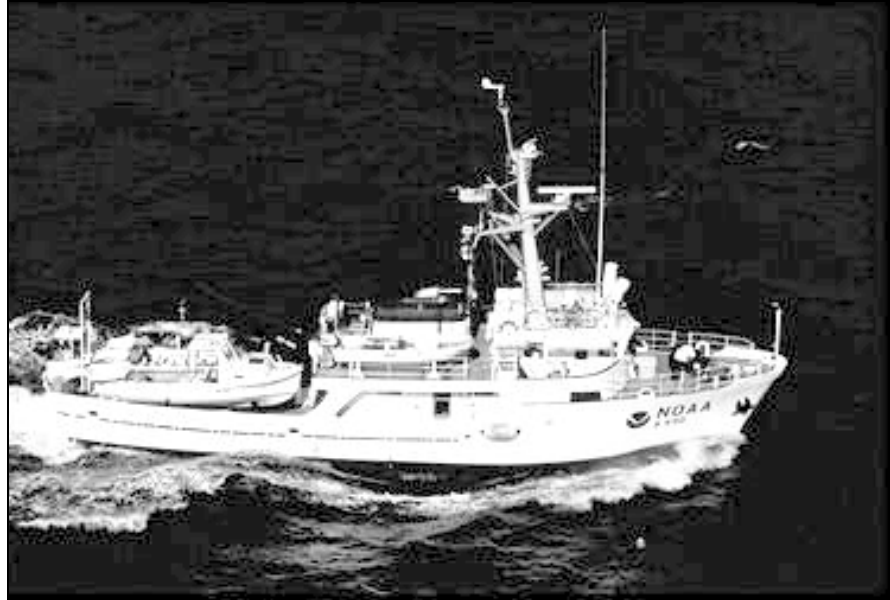
NOAA R/V RUDE

<i>Description:</i>	Survey Ship
<i>Owner:</i>	National Oceanic and Atmospheric Administration (NOAA)
<i>Features:</i>	100kHz side-scan sonar (EG&G 260/272 system by EdgeTech) SEABAT 9001 Bottom Profiling Sonar Isis Sonar Acquisition System (Triton Technology)
<i>Primary assignment:</i>	Debris mapping
<i>Period on site:</i>	17 July to 1 August 1996
<i>Length:</i>	90 feet
<i>Beam:</i>	22 feet
<i>Displacement:</i>	220 tons
<i>Complement:</i>	11 (4 officers, 7 crew)

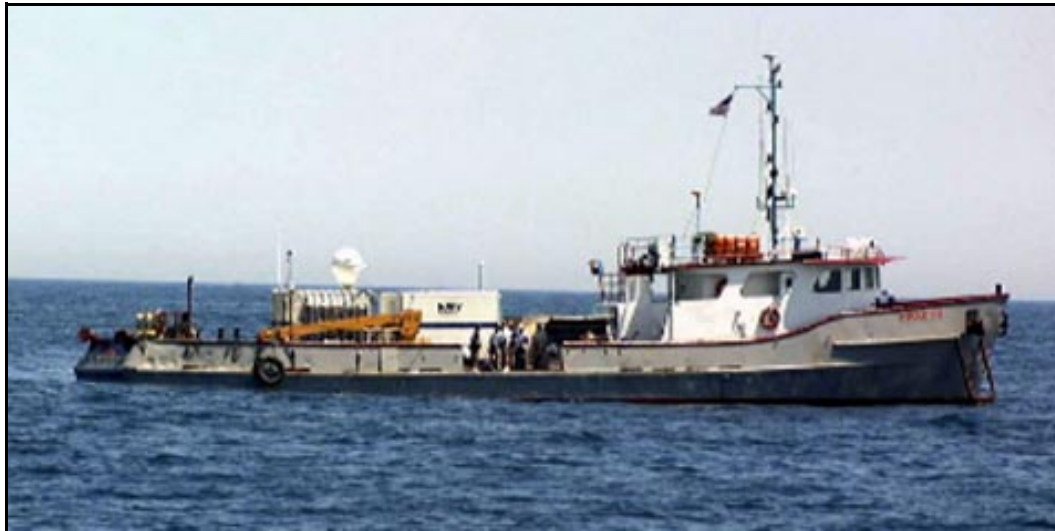
M/V PIRQUETTE

<i>Description:</i>	Search Vessel
<i>Owner:</i>	Divemasters Inc. of Toms River, NJ (chartered by Oceaneering International, Inc. for the U.S. Navy)
<i>SUPSALV systems:</i>	Shallow Water Intermediate Search System (SWISS) (see page B-16) Towed Pinger Locator system (see page B-17) Mini-ROV 2 (see page B-19) Isis Sonar Acquisition System (Triton Technology)
<i>Primary assignment:</i>	Debris mapping
<i>Period on site:</i>	19 July to 12 September 1996

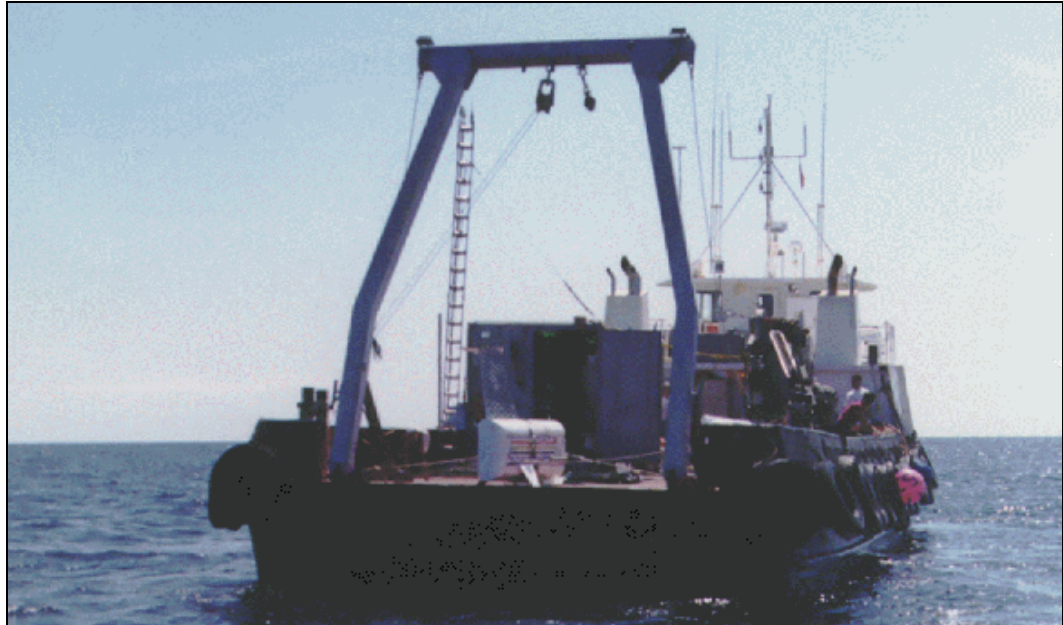
M/V DIANE G

<i>Description:</i>	Search Vessel
<i>Owner:</i>	Science Applications International Corporation (SAIC) (under contract to Oceaneering International, Inc. for the U.S. Navy)
<i>Installed systems:</i>	SM 2000 Laser line scanning (see page B-21) Side-scan sonar
<i>Primary assignment:</i>	Debris mapping and identification
<i>Period on site:</i>	27 July to 11 August 1996

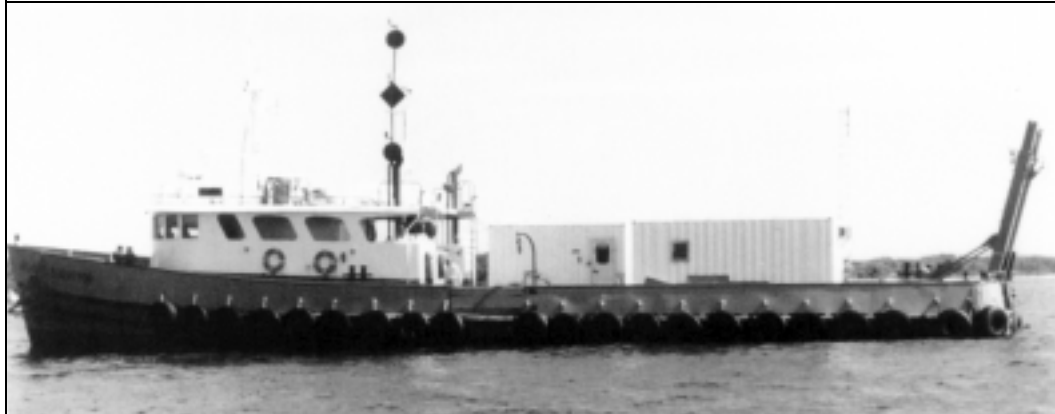
M/V ATLANTIC SURVEYOR

<i>Description:</i>	Search Vessel
<i>Owner:</i>	Divemasters Inc. of Toms River, NJ (chartered by Oceaneering International, Inc. for the U.S. Navy)
<i>SUPSALV systems:</i>	Mini-ROV 2 (see page B-19)
<i>Primary assignment:</i>	Final quality assurance check in trawl area
<i>Period on site:</i>	6 to 8 May 1997
<i>Length:</i>	110 feet
<i>Beam:</i>	26 feet
<i>Complement:</i>	16

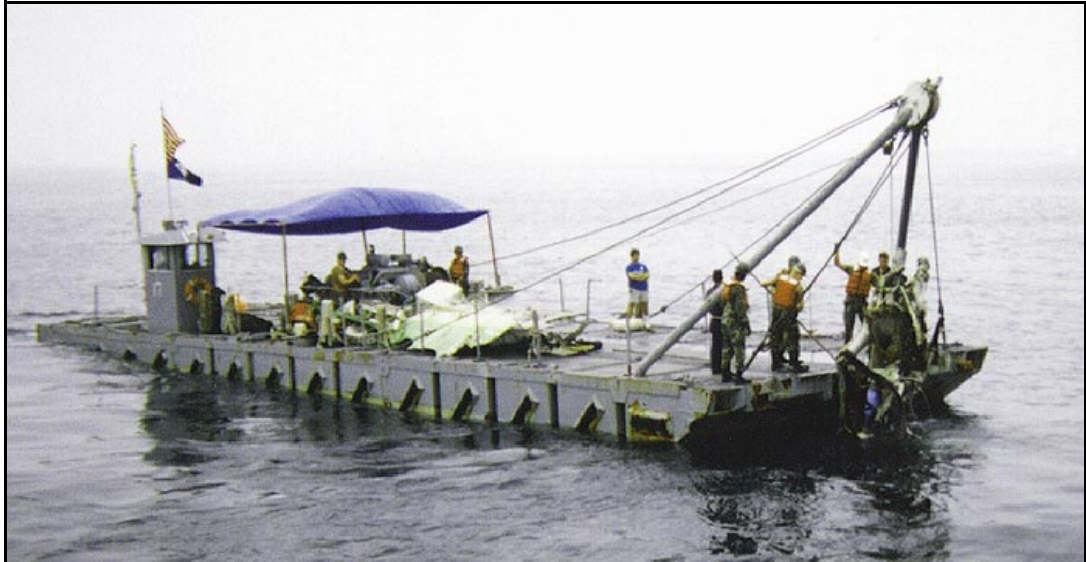
Side Loading Warping Tug (SLWT)

<i>Description:</i>	Warping Tug
<i>Owner:</i>	U.S. Navy
<i>Features:</i>	A-frame winch with lifting capacity of 12 tons
<i>Primary assignment(s):</i>	Recovery of debris rigged by Mobile Dive Teams; surface-supplied dive platform
<i>Period on site:</i>	23 July to 18 October 1996
<i>Length:</i>	84 feet
<i>Beam:</i>	21¼ feet
<i>Displacement:</i>	110 tons
<i>Complement:</i>	8 (enlisted)

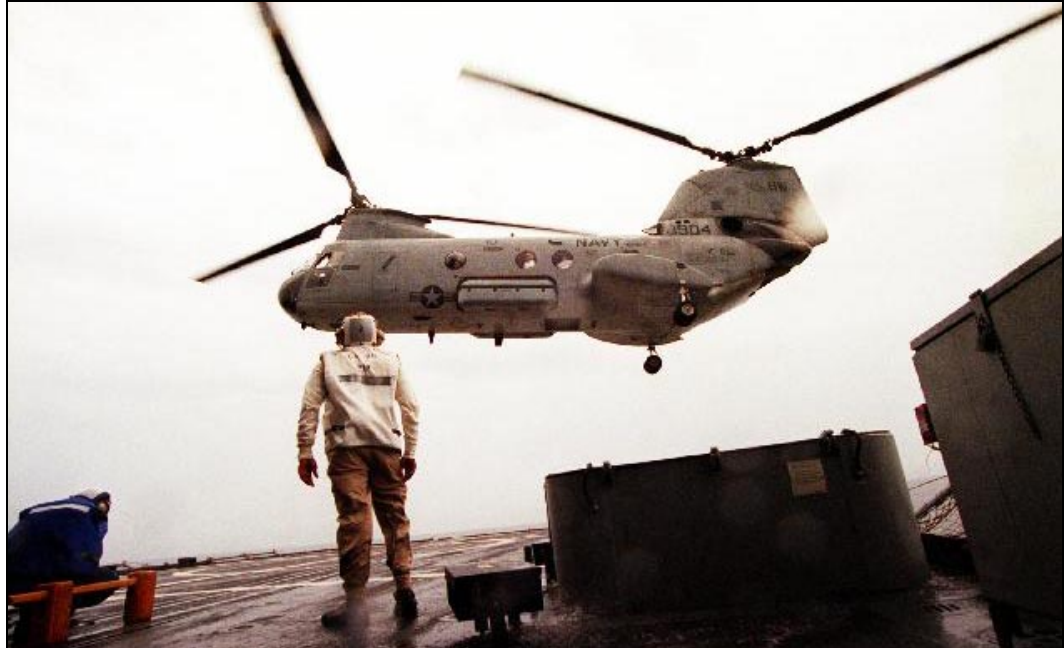
CH-46 "Sea Knight" Helicopter

<i>Description:</i>	Cargo Helicopter
<i>Owner:</i>	U.S. Navy
<i>Primary assignment:</i>	Transportation of debris, personnel, and stores
<i>Period on site:</i>	23 July to 2 November 1996
<i>Fuselage Length:</i>	46 feet, 8 inches
<i>Height:</i>	16 feet, 8 inches
<i>Weight:</i>	15,198 pounds empty, 24,300 pounds maximum takeoff
<i>Crew:</i>	3 (1 pilot, 1 copilot, 1 crewman)

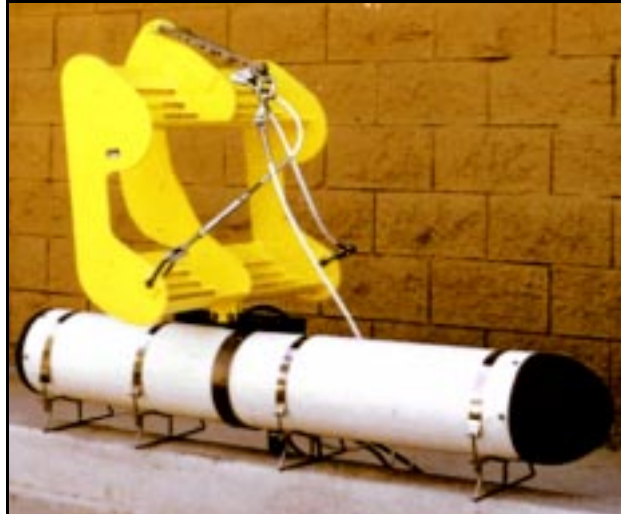
SUPSALV Towed Pinger Locator System

<i>Description:</i>	Towed Pinger Locator (TPL) System
<i>Owner:</i>	U.S. Navy
<i>Features:</i>	Highly sensitive underwater microphones
<i>Primary assignment:</i>	Detection of aircraft flight recorders, working from M/V PIROUETTE (see page B-8)
<i>Period on site:</i>	20 July to 14 September 1996
<i>Length:</i>	72 inches
<i>Weight:</i>	500 pounds
<i>Diameter:</i>	12 inches
<i>Depth Rating:</i>	20,000 feet

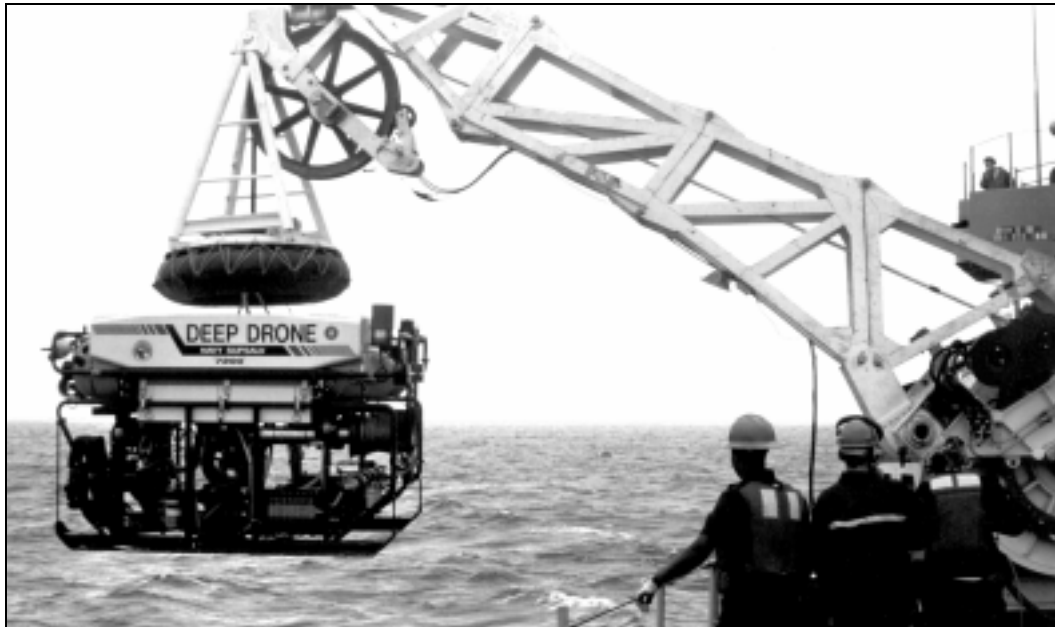
SUPSALV Deep Drone 7200

<i>Description:</i>	Remotely Operated Vehicle
<i>Owner:</i>	U.S. Navy
<i>Features:</i>	Target-locating sonar, color and black-and-white television cameras, 35mm camera, two 7-function manipulators
<i>Primary assignment:</i>	Location of victims, identification of debris, recovery of debris, and underwater still and video photography, working from the USS GRAPPLE (see page B-4) and M/V MARION C II (see page B-10).
<i>Period on site:</i>	29 July to 6 November 1996
<i>Length:</i>	9 feet 3 inches
<i>Width:</i>	4 feet 7 inches
<i>Height:</i>	6 feet 2 inches
<i>Weight:</i>	3,500 pounds
<i>Lift Capacity:</i>	3,200 pounds (via vehicle)
<i>Depth Rating:</i>	7,200 feet
